nota WWKZ-84.V031

PERMEABLE GROYNES: EXPERIMENTS AND PRACTICE IN
THE NETHERLANDS

W.T. Bakker*, C.H. Hulsbergen**, P. Roelse*, C. de Smit***
and J.N. Svasek***

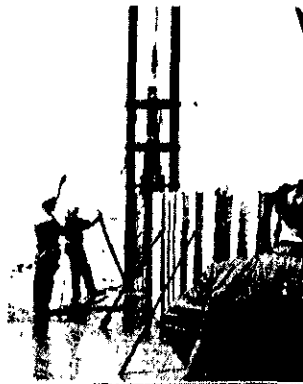
FIG.8 Construction of screens

10, ②), in 1968 the existing coastal protection (consisting of heavy massive groynes with piles on top) was extended in SE direction by means of three long double screens and two short single screens (Fig. 11, and lower photo on Fig. 8). Since then the discontinuity in the coastline, caused by the leeside scour resulting from the original system, was evened out. Even some accretion occurred directly southward of the former end of the groyne system. The leeside scour shifted to the end of the new screen system. This project indicates that these pile screens do have the expected effect.
