CURRENT PATTERN IN THE COASTAL AREA IN THE SOUTHWESTERN PART OF THE NETHERLANDS

POLAR DIAGRAMS OF CURRENT VELOCITY AND DIRECTION IN THE COASTAL AREA OF THE SOUTHWESTERN PART OF THE NETHERLANDS

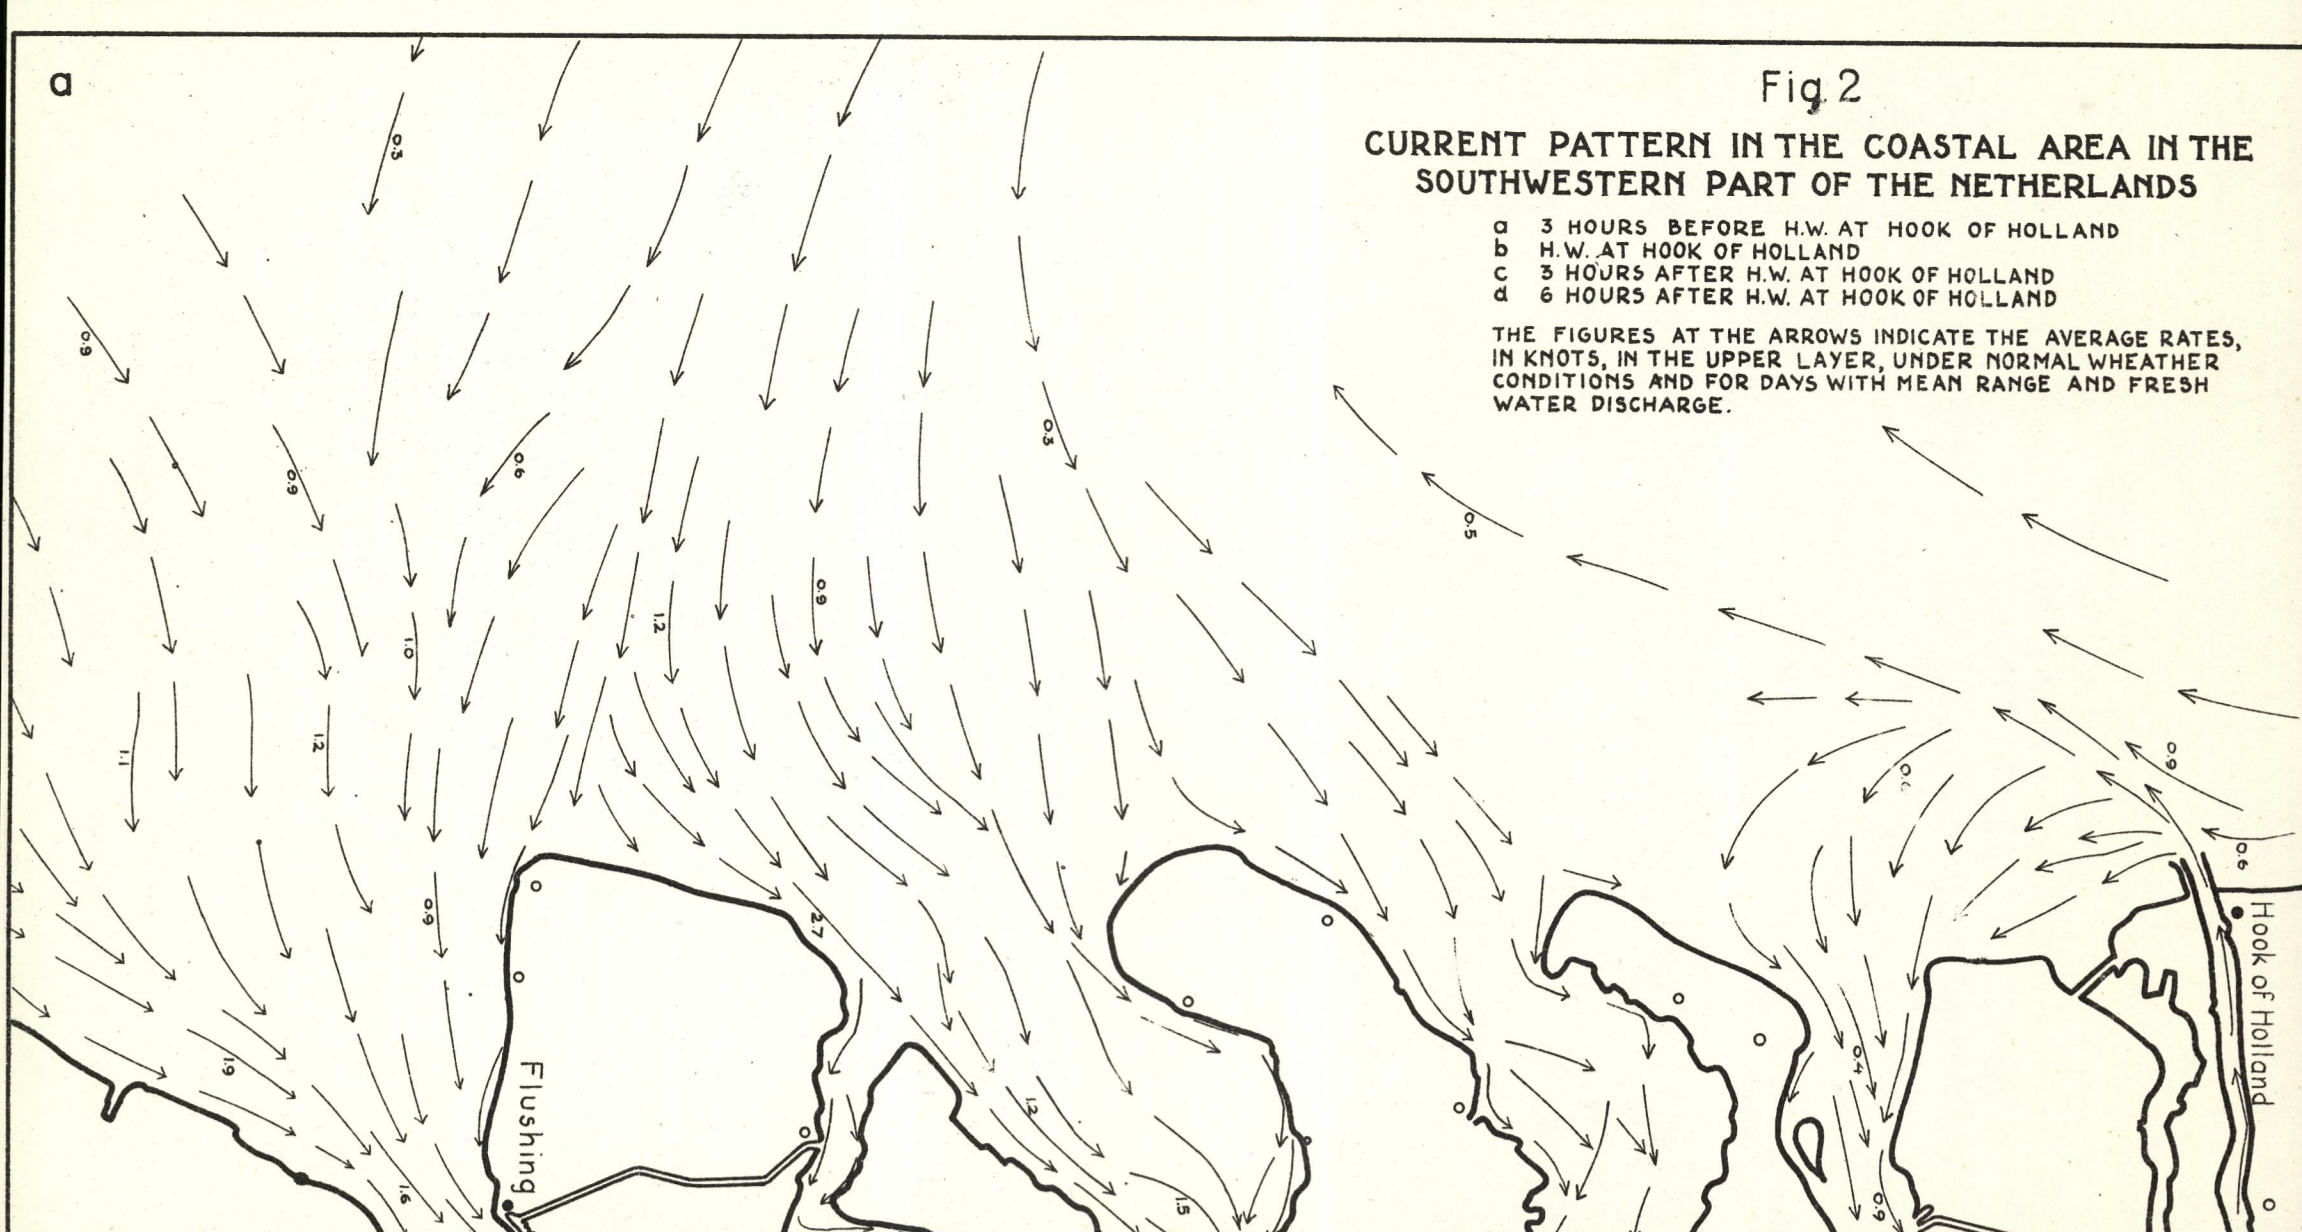
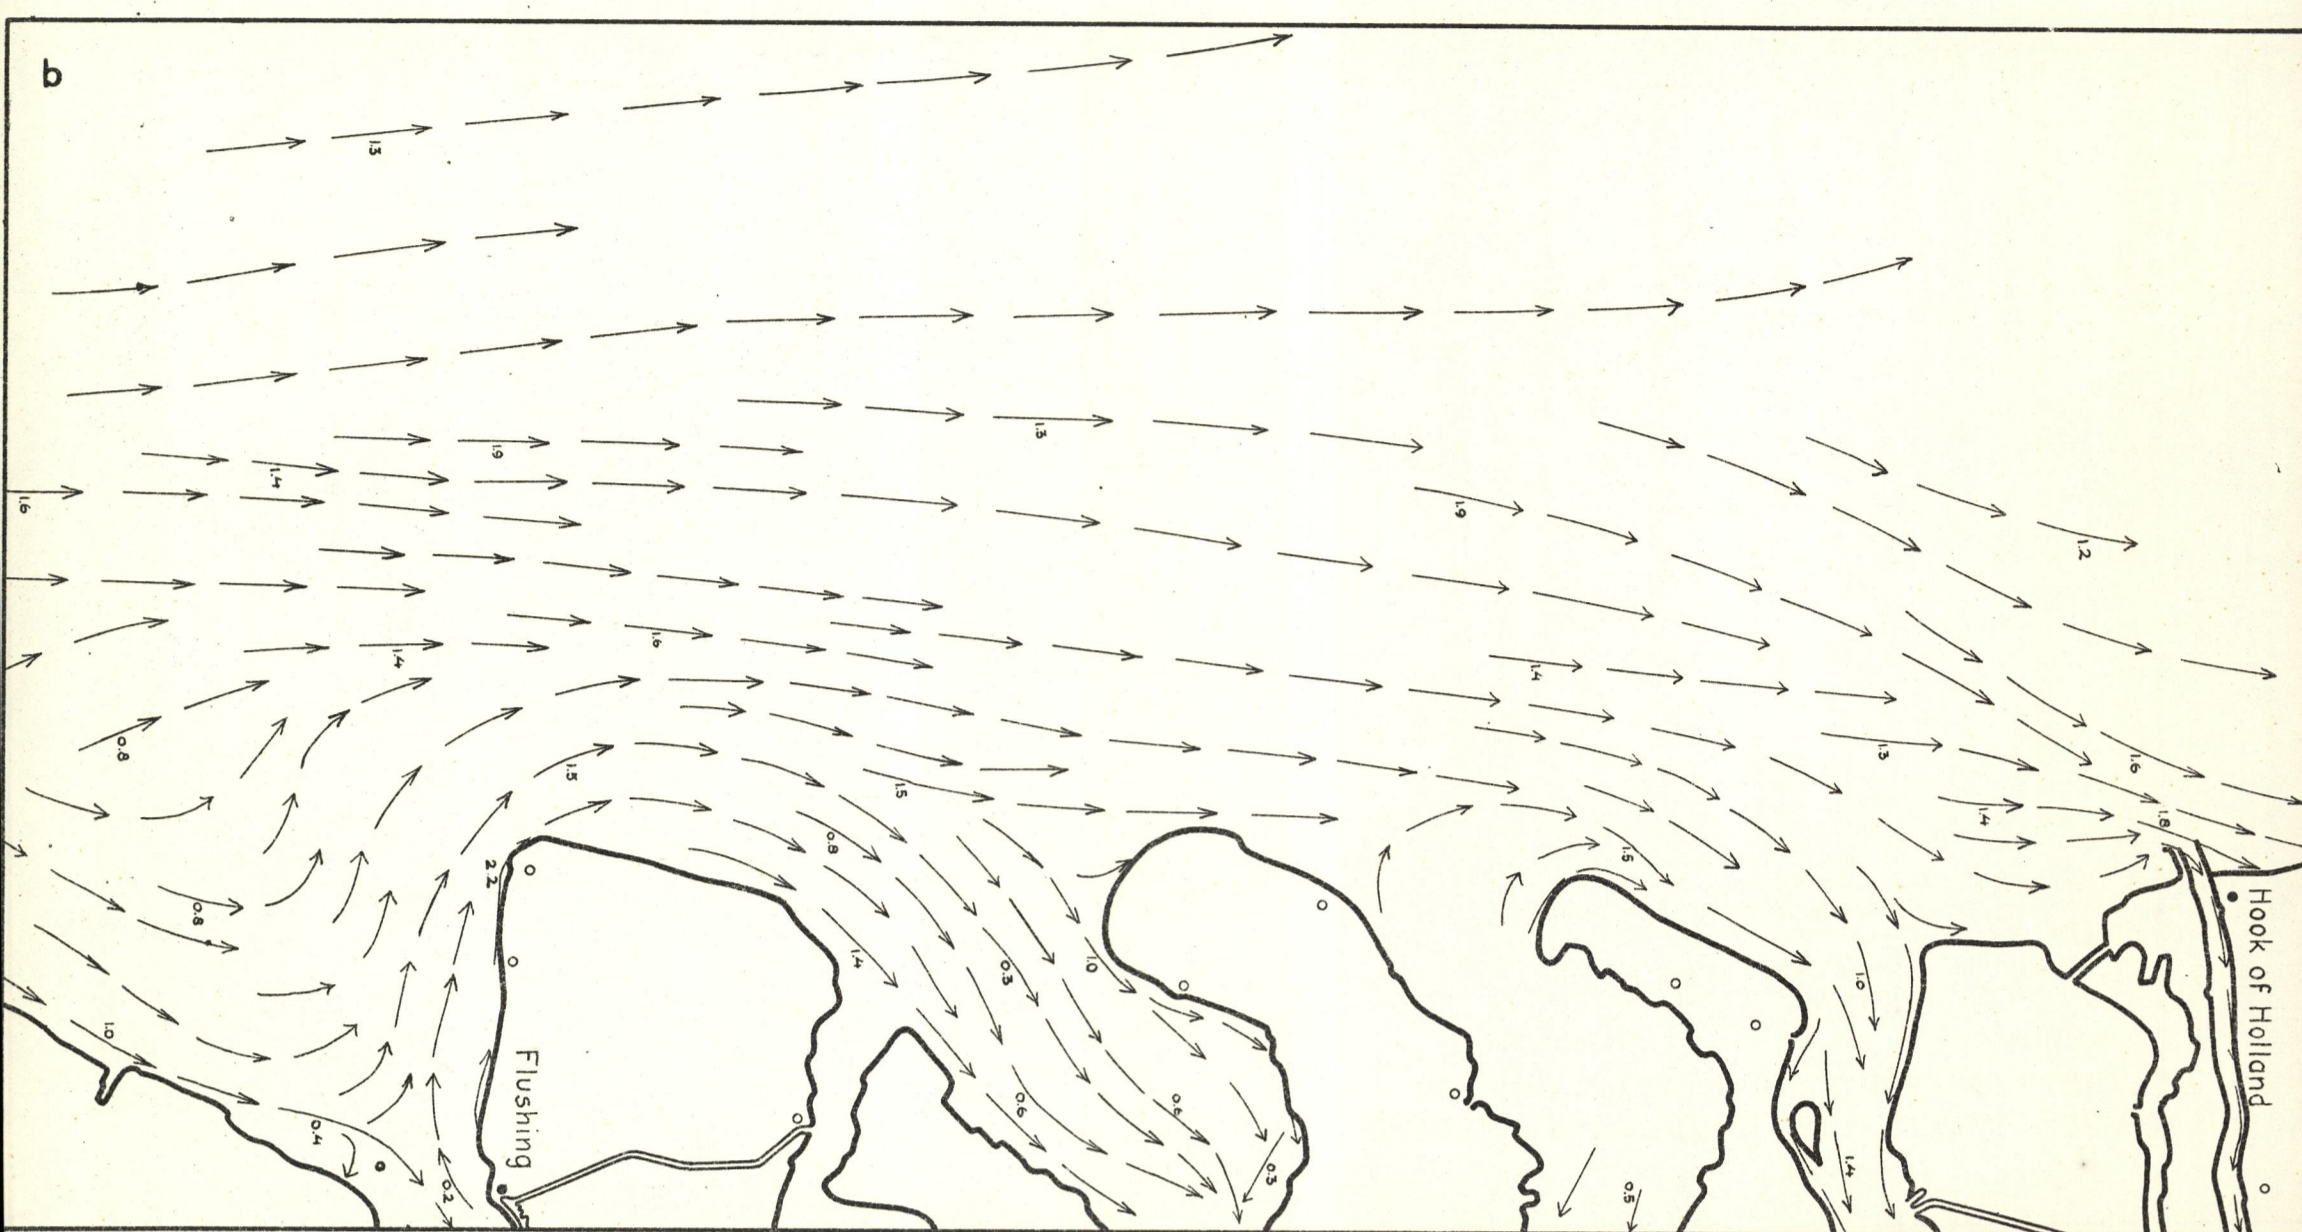
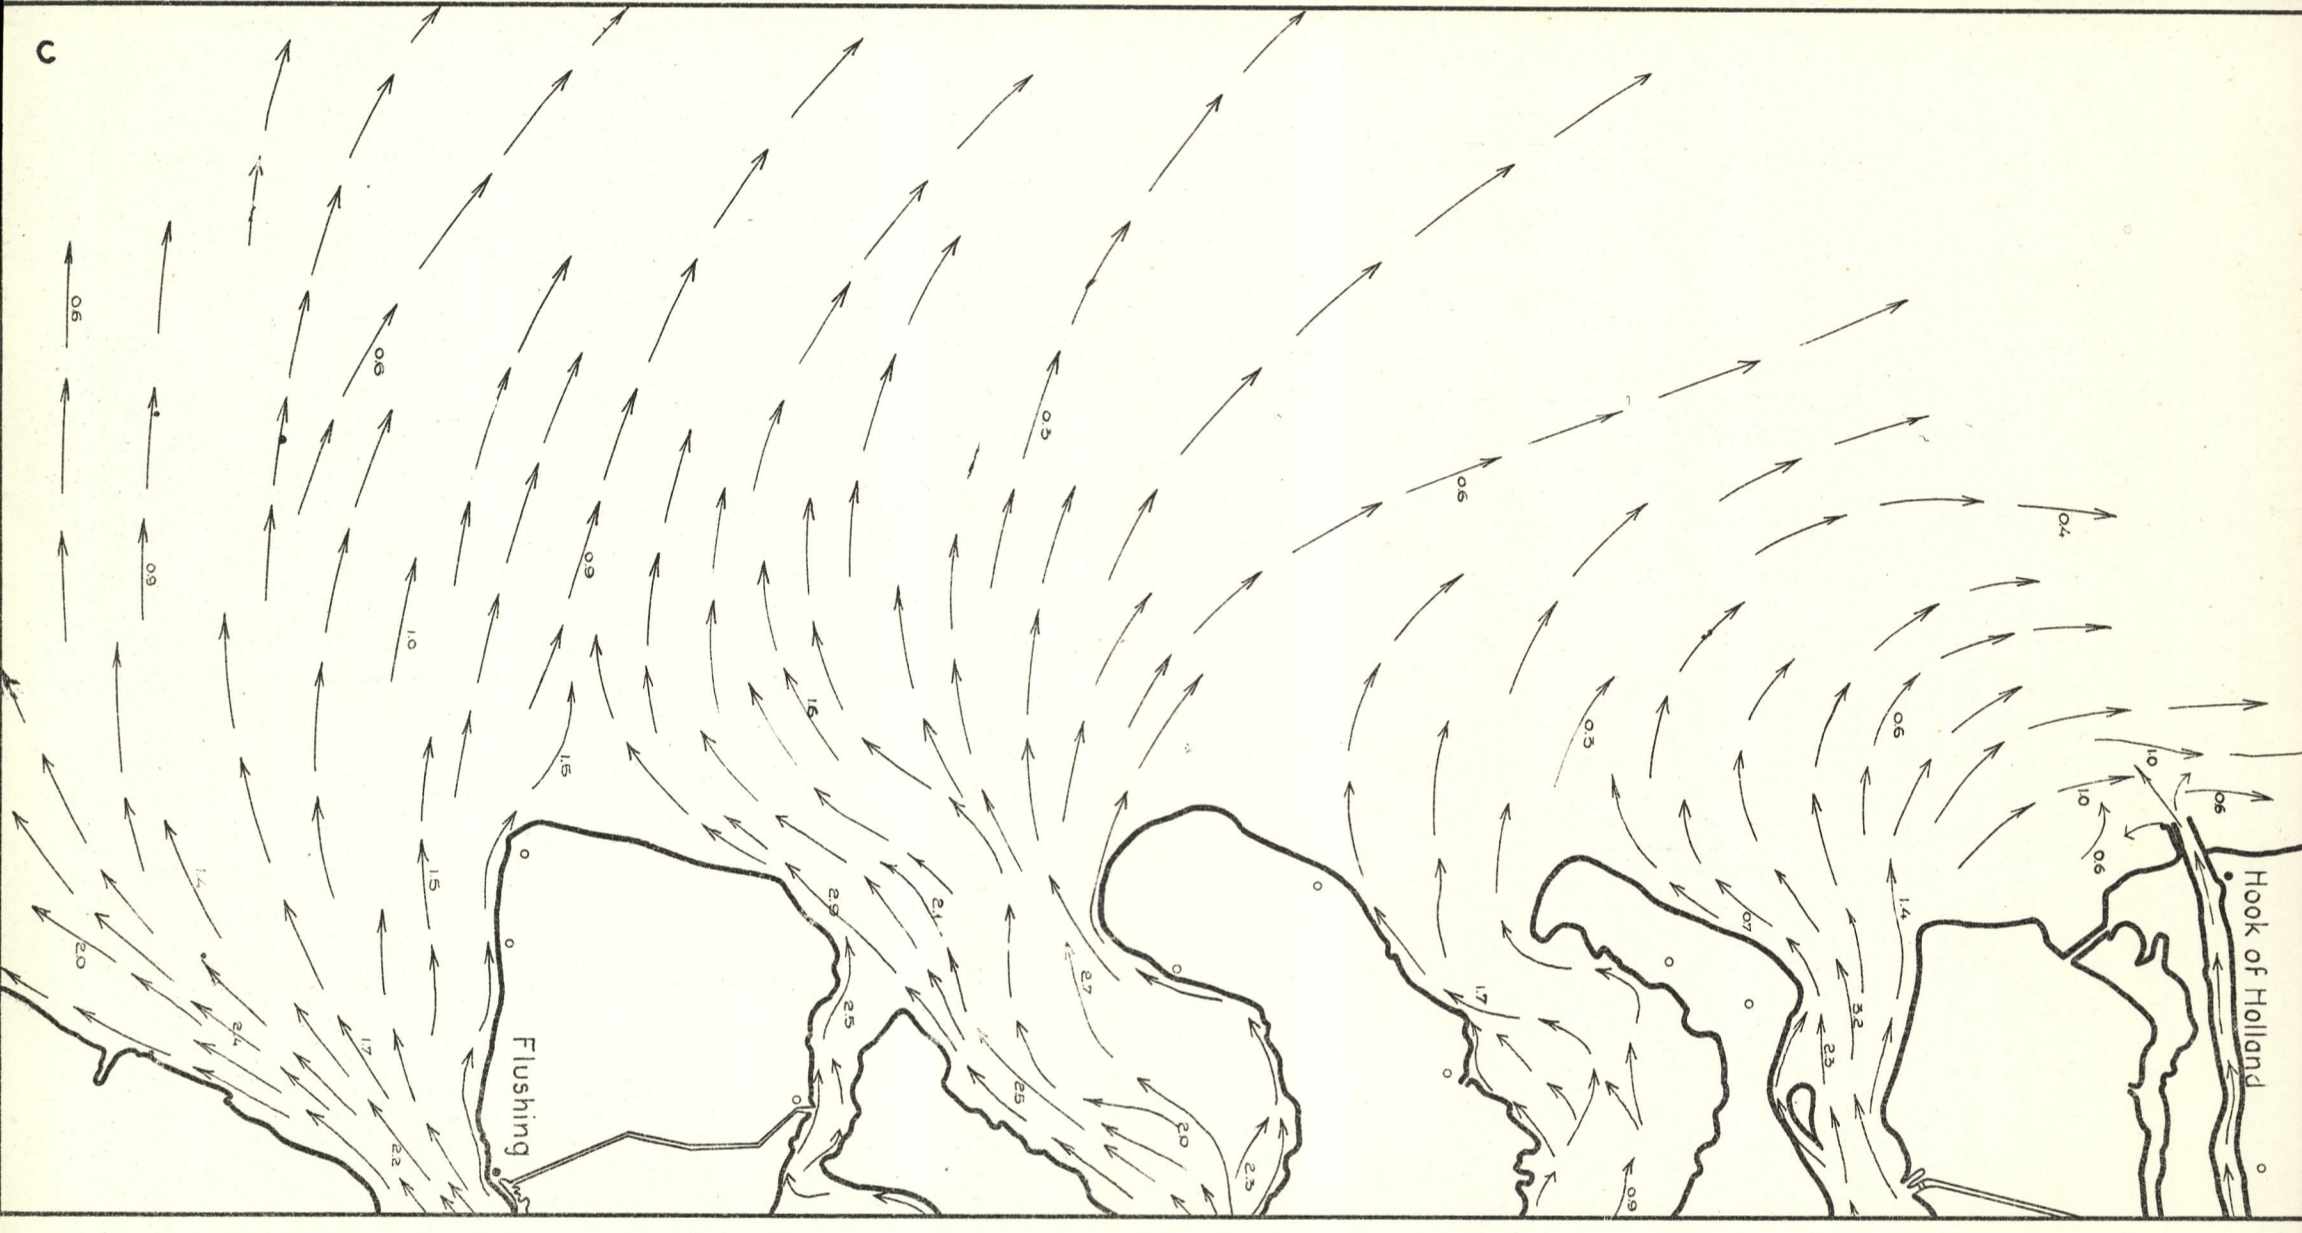
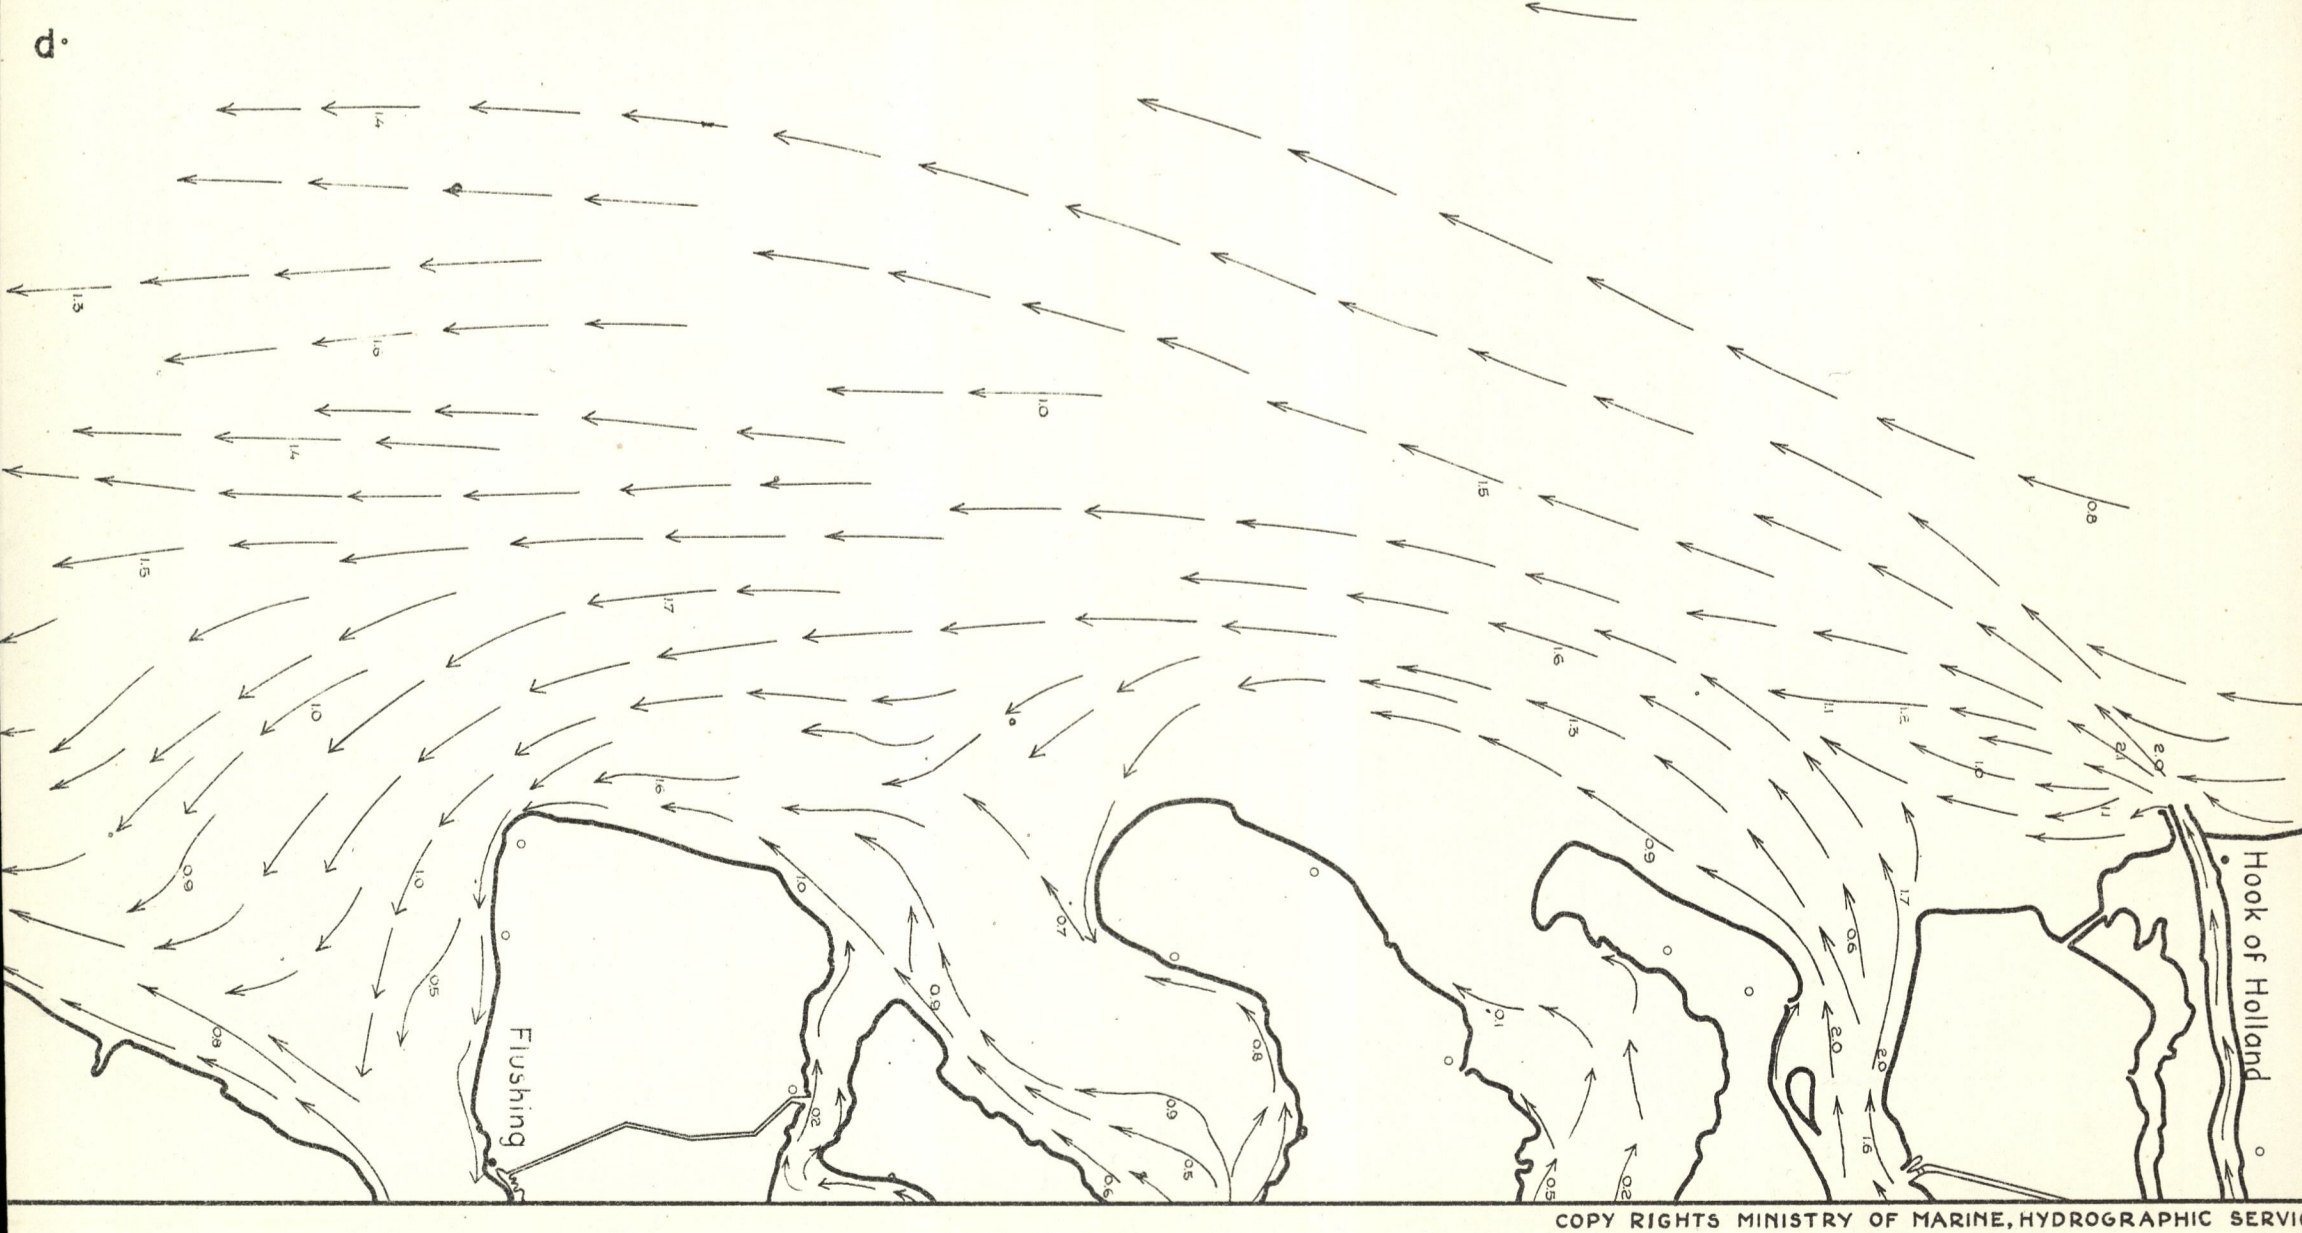
Fig 2

- a 3 HOURS BEFORE H.W. AT HOOK OF HOLLAND
- b H.W. AT HOOK OF HOLLAND
- c 3 HOURS AFTER H.W. AT HOOK OF HOLLAND
- d 6 HOURS AFTER H.W. AT HOOK OF HOLLAND

THE FIGURES AT THE ARROWS INDICATE THE AVERAGE RATES, IN KNOTS, IN THE UPPER LAYER, UNDER NORMAL WEATHER CONDITIONS AND FOR DAYS WITH MEAN RANGE AND FRESH WATER DISCHARGE.

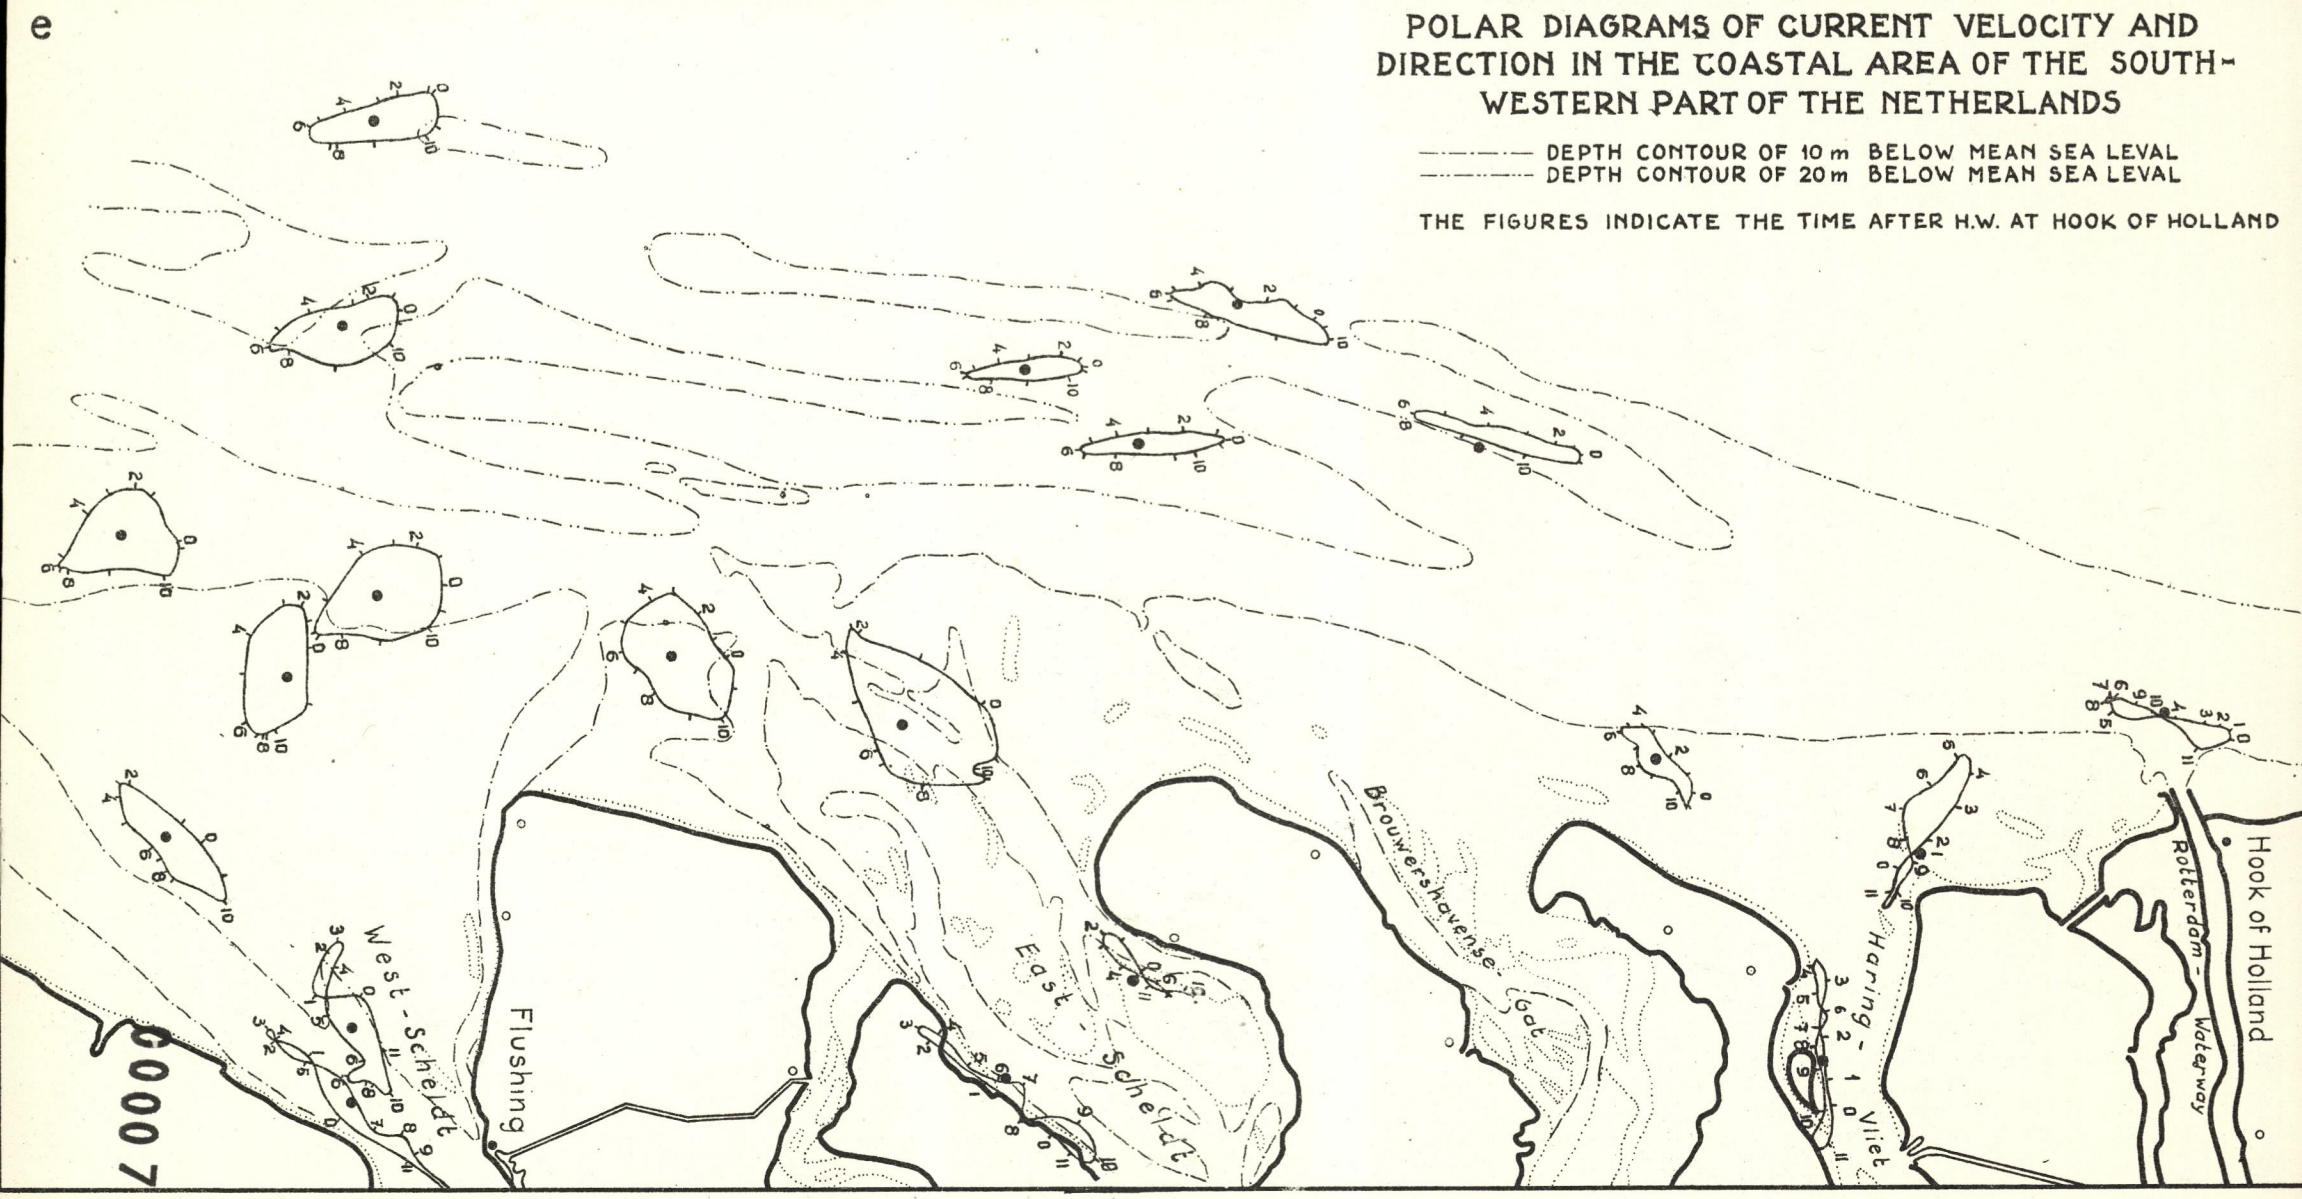
- DEPTH CONTOUR OF 10 m BELOW MEAN SEA LEVEL
- - - DEPTH CONTOUR OF 20 m BELOW MEAN SEA LEVEL

THE FIGURES INDICATE THE TIME AFTER H.W. AT HOOK OF HOLLAND
